AM35x ARM Microprocessor **Silicon Revisions 1.1, 1.0**

Errata

Literature Number: SPRZ306B
October 2009–Revised July 2010

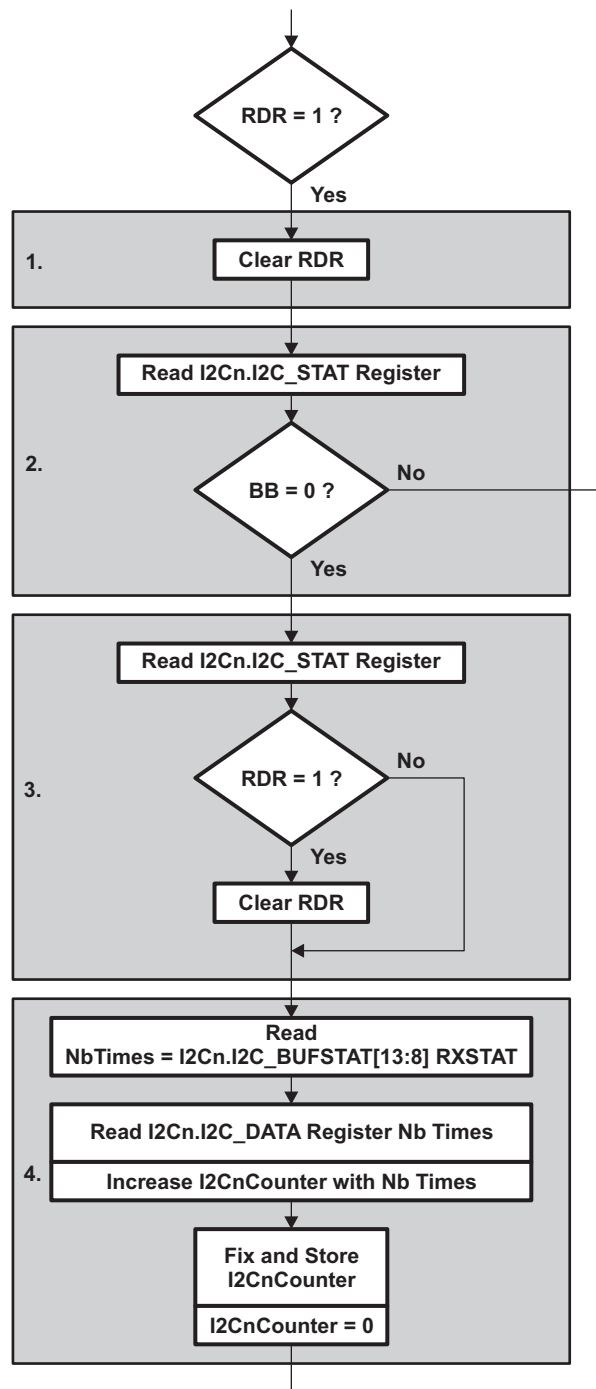
Figure 2. I2C Flowchart

Revision(s) Affected 1.1 and earlier**Details** Under certain rare conditions, the I2C_STAT[13].RDR bit may be set as well as the corresponding interrupt fire, even when there is no data in the receive FIFO, or the I2C data transfer is still ongoing. These spurious RDR events must be ignored by the software.**Workaround(s)** Software must filter out unexpected RDR pulses, using the flowchart illustrated in [Figure 2](#) when receiving an I2C RDR interrupt.

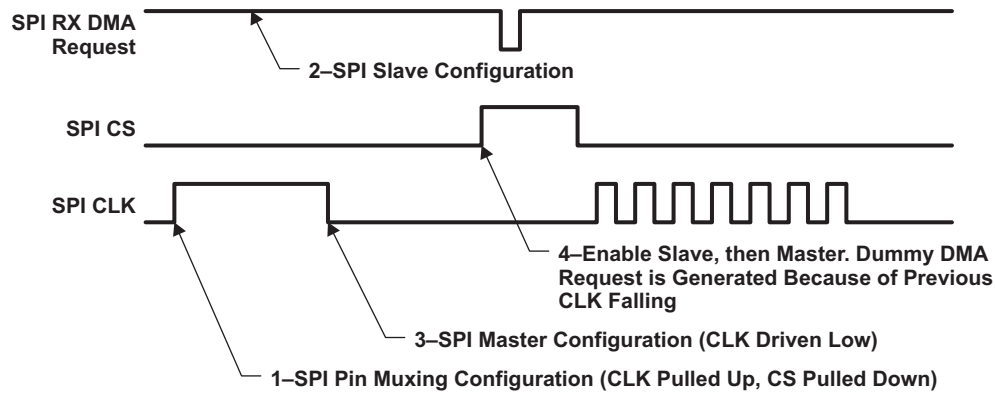
Figure 3. SPI Dummy DMA RX Generation

Details A dummy DMA RX request is generated as soon as the SPI is configured in *slave* mode and a SPI clock edge is detected. The dummy DMA RX request is generated during module configuration, when the module is not performing an SPI transfer. The dummy DMA RX request occurs as soon as the SPI interface signal sensitivity is changed compared to the default value.

The dummy DMA RX request is generated because the mechanism to avoid dummy data capture on a CS glitch is done regardless of channel activation.

Workaround(s) Avoid conditions where the SPI is in *slave* mode and the SPI clock toggles (see examples below).
